FINAL  
KNKT.09.08.21.04

Aircraft Accident Investigation Report

PT. Merpati Nusantara Airline  
De Haviland DHC6 Twin Otter; PK-NVC  
Near Ambisil / Okbibab, PAPUA  
Republic of Indonesia

2 August 2009

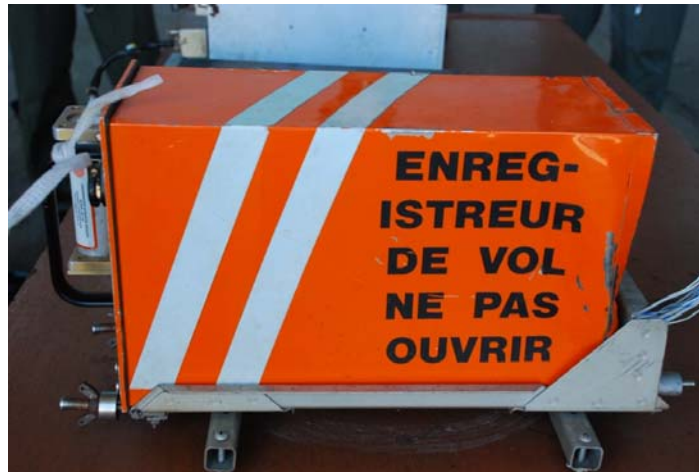
**Figure 2: Cockpit Voice Recorder from Twin Otter PK-NVC**

The aircraft was not equipped with flight data recorder (FDR). Indonesian regulations did not require a FDR to be fitted to the Twin Otter aircraft.<sup>6</sup> However, the aircraft was equipped with a Cockpit Voice Recorder (CVR). Indonesian Civil Aviation Regulations required that a serviceable CVR was required to be fitted to the Twin Otter aircraft. Search and Rescue personnel recovered the CVR from the wreckage and handed it over to NTSC investigators. The outer box had minor damage, but the contents were not damaged.

The 30-minute recording on the cockpit voice recorder contained good quality data.

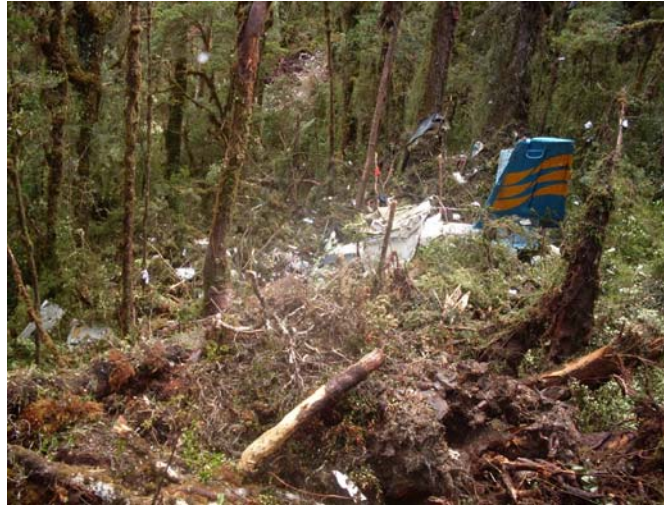
**Figure 3: Wreckage of Twin Otter PK-NVC**

The aircraft struck trees, in a left banking turn, before it impacted the ground. The wings separated from the fuselage as it struck the trees. The aircraft was severely disrupted and fragmented by the impact forces.
